Performance of dolomitic cementitious mortars as a repairing material for normal concrete in Egypt

Érkezett: 2019. 02. 12. ▪ Received: 12. 02. 2019. ▪ <https://doi.org/10.14382/epitoanyag-jsbcm.2019.7>

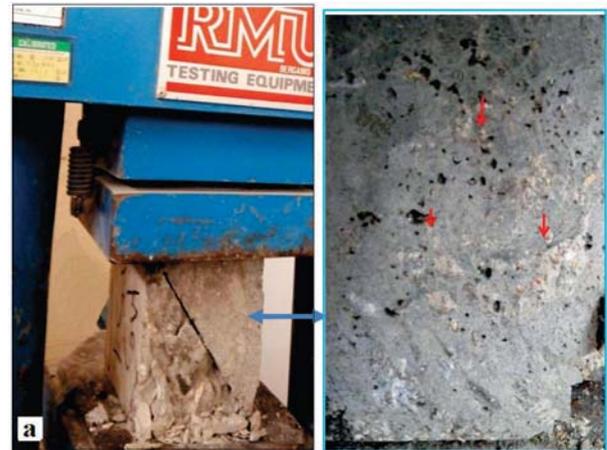
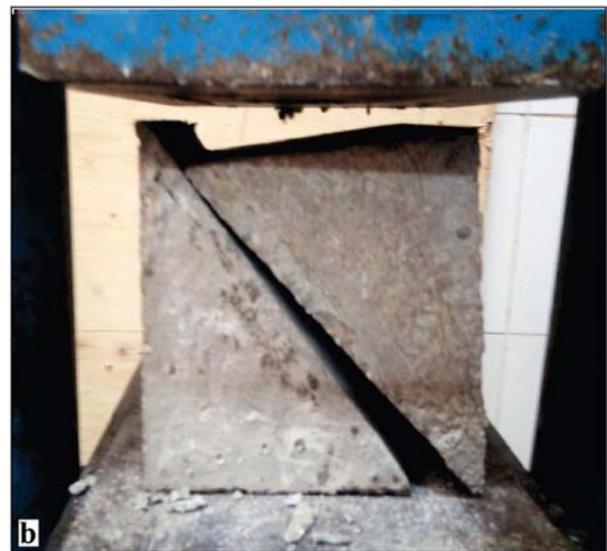
Fig. 9. a) 5% EPP mortar sample shows interface failure with partial damage and attached traces of substrate (right), b) interface failure with complete separation

Mortars mixed with CS show relatively high reduction in slant shear strength when compared with others. Replacement with 15% CS shows the lowest value (22 MPa) between all studied samples. The failure occurred only at the interface where complete separation of substrate and repair occurred, (Fig 9.b). The lack of pozzolanic activity in CS may be the main reason of reduction in its bond strength. Also, relatively high shrinkage observed by CS mortars may reduce bonding efficiency by initial tensile strain induced in the repair [45].
